Case Study of a Watershed Rehabilitation Project: Alkali Creek, Colorado

Burchard H. Heede

USDA Forest Service
Research Paper RM-189
June 1977

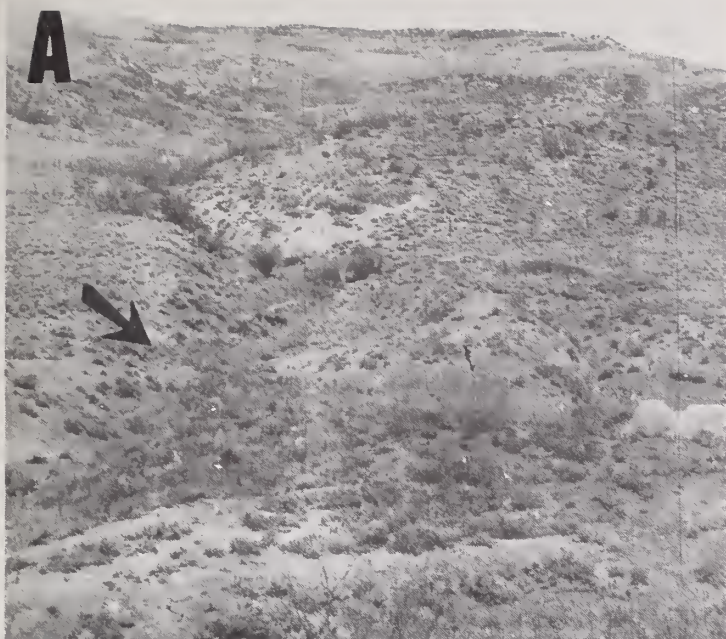
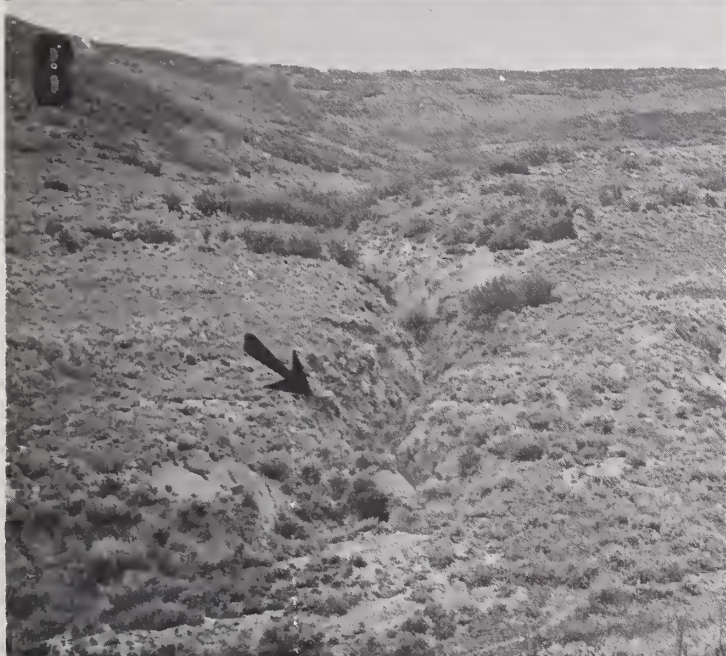
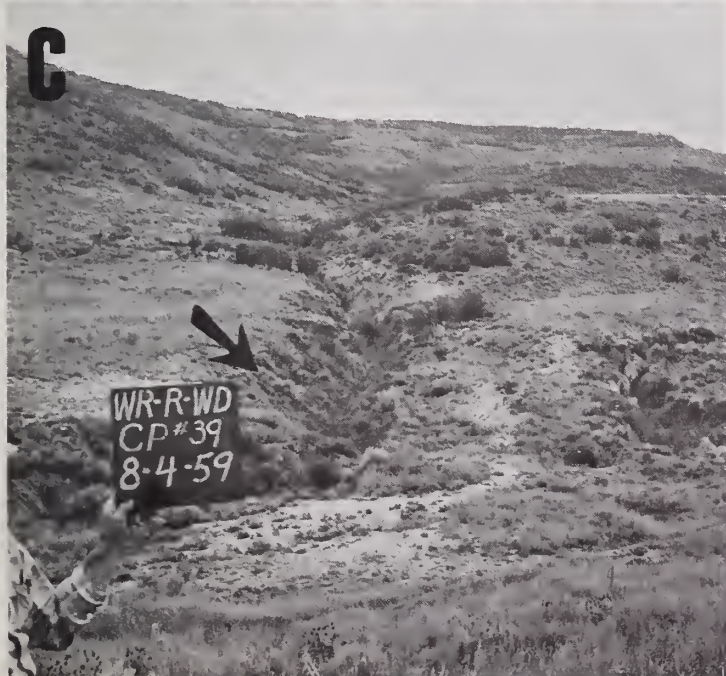
As early as 1915, permanent camera points were established to document changes. One of the old photographs (fig. 3A) shows that the main gully could have been crossed on horseback or even by a horse-drawn wagon whereas, 35 yr later, it had developed to a depth of about 25 ft (fig. 3B). A drastic increase in bare ground surrounding this gully can be recognized on a 1959 photograph (fig. 3C), 44 yr after the first picture was taken.

must be interpreted in this context, and we may surmise that increased gullying, of the magnitude shown by the figure, was the combined effect of drought and overgrazing as well as overuse on the agricultural lands below the watershed. Overuse of the lowlands led to greater incision of the channels which resulted in a lowering of the base level for Alkali Creek.

Figure 3.—The main gully as photographed in 1915 (A). Note that it can still be crossed by wagon or on horseback (see arrow for location). By 1949, the gully had deepened and the gully side slopes steepened (B). Gully crossing is possible only on foot. By 1959, 44 yr after the first picture was taken, the gully had deepened and widened further (C), and bare ground increased.

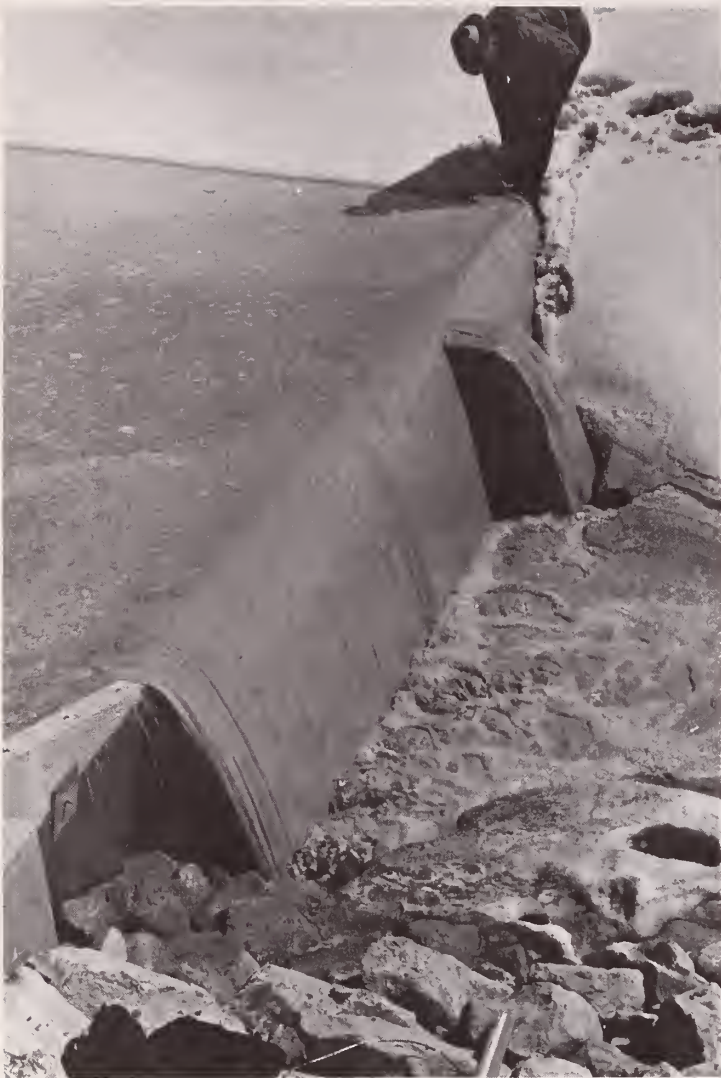
Figure 4.—The upstream face of this slab-buttress dam is inclined at an angle of about 10° from the vertical, causing the wall to lean downstream and discharge the water overfall away from the toe of the structure. This is the first runoff, 9 months after installation. Stage is beginning to rise for the daily peak.

Maintenance has not yet been required at the prefabricated concrete dam, but the center but-

trex, manufactured from reinforced lightweight concrete, will eventually require maintenance due to surface flaking. Freeze and thaw actions are mainly responsible; porosity of lightweight concrete is much higher than that of normal-weight concrete. The dam slabs, built of prestressed normal-weight concrete, appear like new.

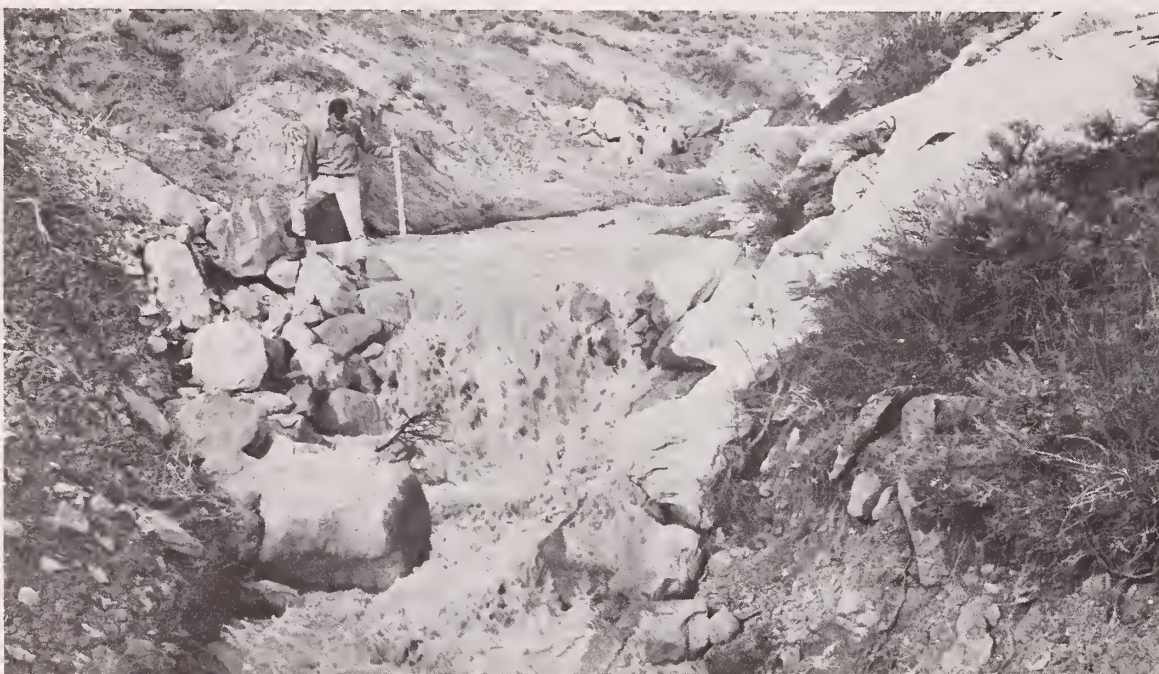
Figure 5.—Upstream view of loose rock check dam during second snowmelt runoff season after construction. Effective dam height is 7 ft. Discharge is approximately 12 cfs.

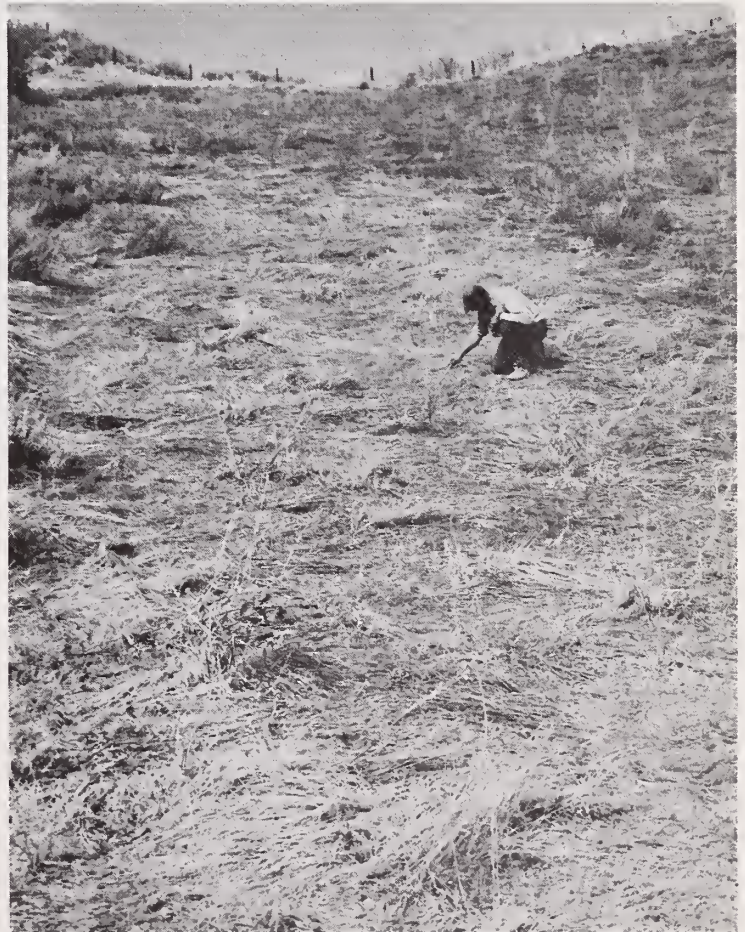
Figure 6.—Waterway 6, 4 yr after treatment, shortly after disappearance of the snowpack. Note the dense mat of plants and litter that provided effective armoring against the snowmelt runoff.

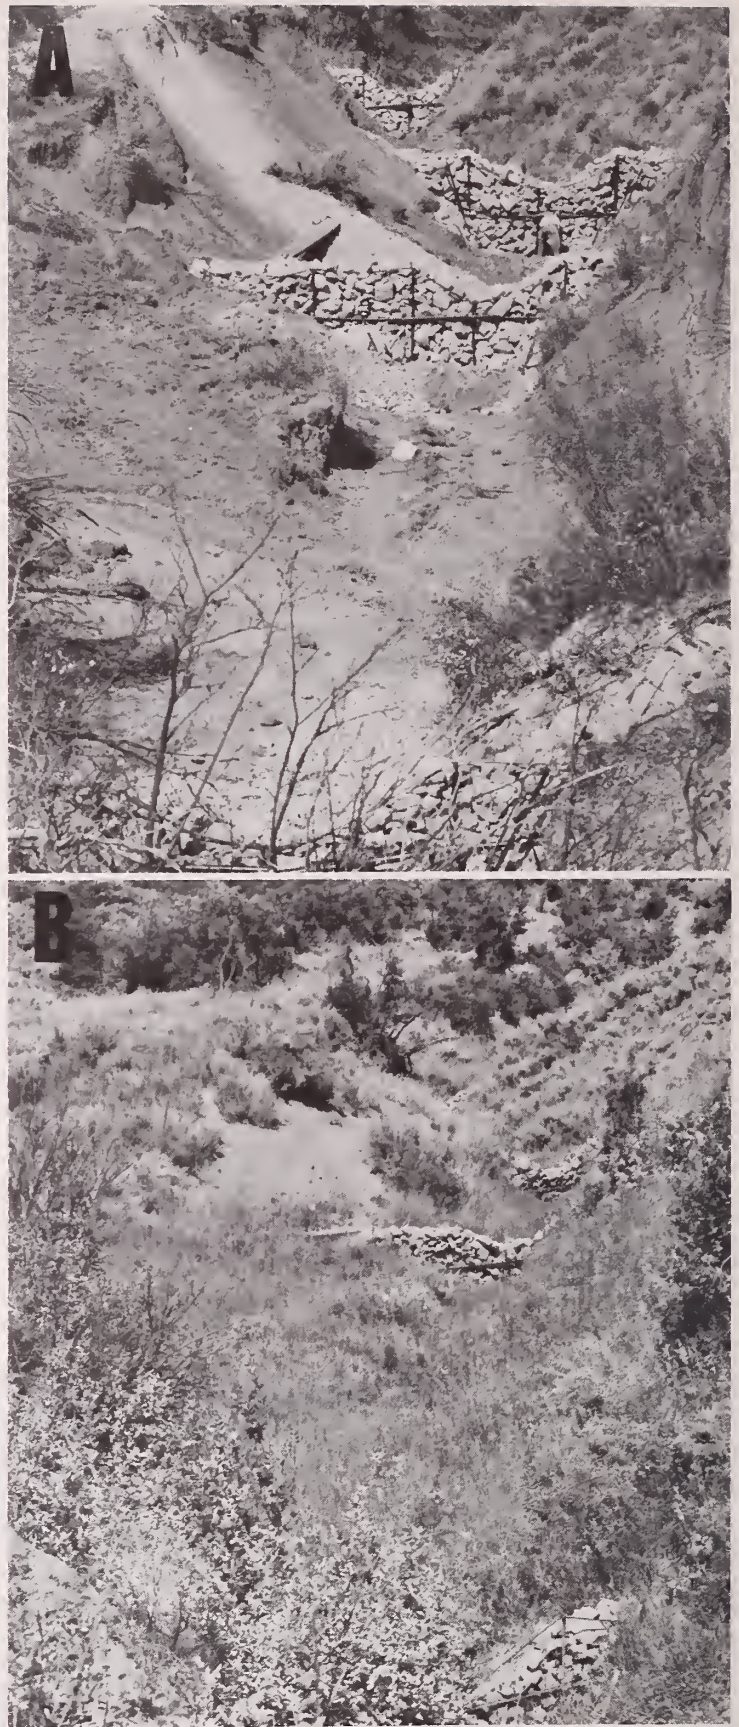
Figure 7.—Upstream view into the headwater reach of the main gully during the last phase of construction (rearrangement of rocks by hand on apron and bank protection work) (A), and 12 yr after treatment (B). The structures are intact. Most channel areas have been invaded by vegetation.

bank stabilization appears to have followed a pattern, well known for hill slope development, of convex rounding of gully brinks (see fig. 7(B)), and concave rounding of bank toes (fig. 10(B)). Carson and Kirkby (1972) claim that this is the result of transport-limited processes, and stems from a combination of weathering, creep, and rainsplash. Especially where the newly shaped banks were invaded by a vegetative cover, a much more stable landform exists now compared with original raw gully banks.

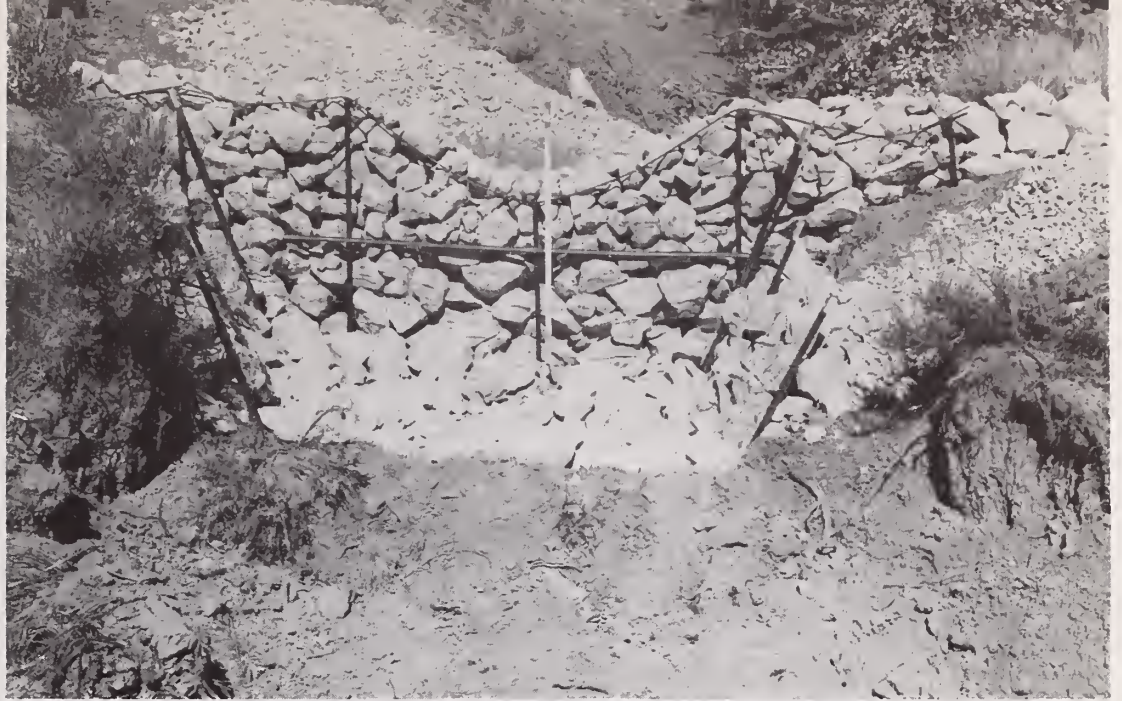
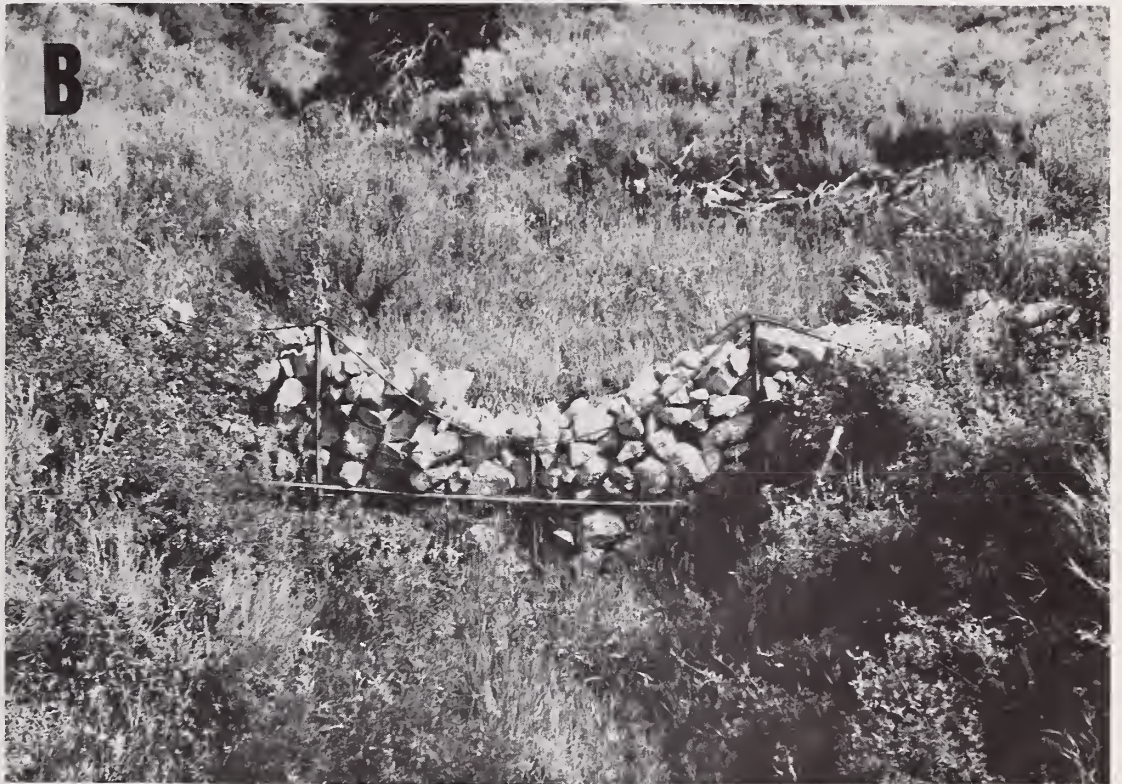
Structural Stability. Rock size distribution in the structures did not follow the contract specifications. It was estimated that large sizes (diameter ≥ 1 ft) made up 80% of the total. Later attempts to break these rock into smaller sizes with a pavement breaker were not successful. Effectiveness of the narrower double-fence dams was reduced most due to large voids caused by lack of smaller rocks, and maintenance was soon required. Loose rock, loose rock wire bound, and single-fence dams were only slightly affected by the poor rock size distribution. Close inspection and maintenance during the first 4 treatment years avoided any structural loss (fig. 7(A), (B)). Practically no maintenance was carried out during the last 7 treatment years. Galvanized wire, steel fenceposts, and rebars used in the dams are still intact (fig. 8(A), (B)).

Figure 8.—Upstream view of new double-fence dam (A). Height of rod is 5.5 ft. Twelve yr later (B), vegetation covers the gully bottom and side slopes, and encroaches upon the apron and bank protection work.

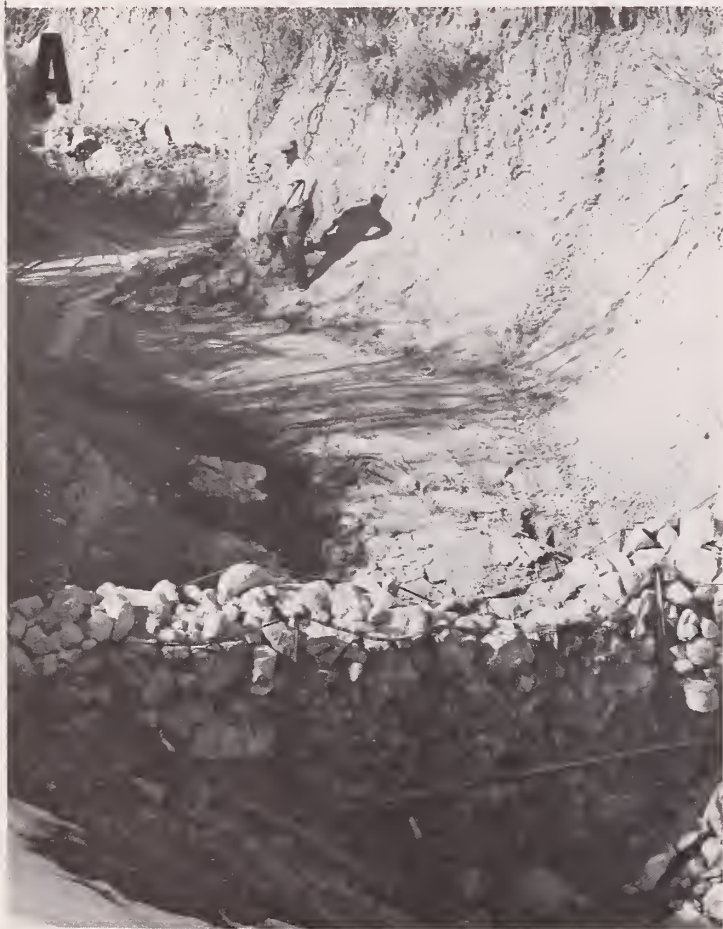
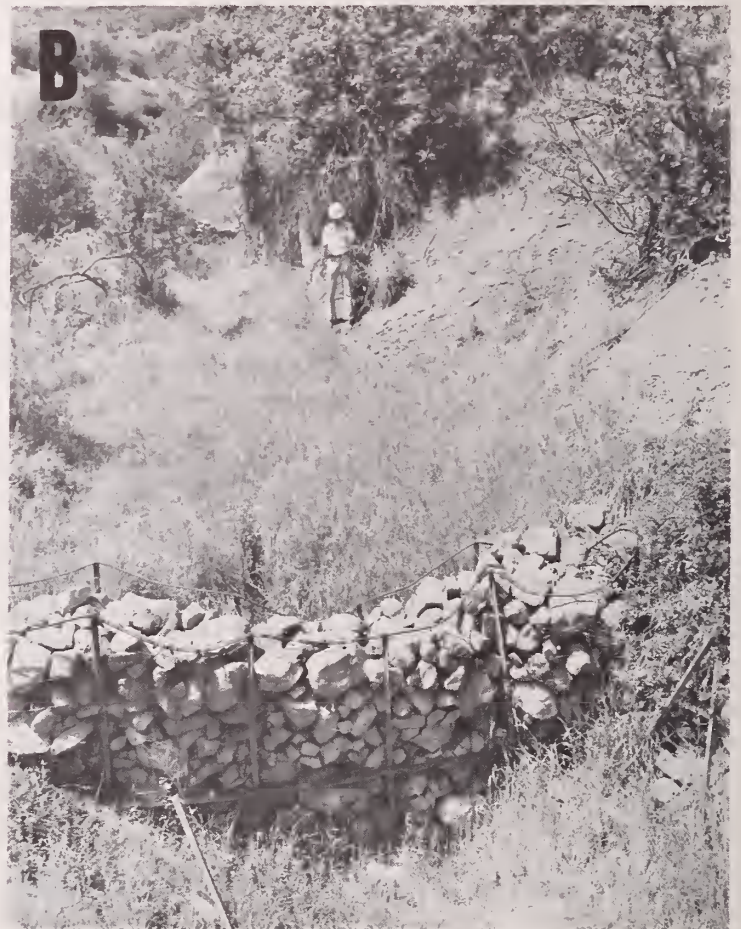
Figure 10.—This double-fence dam, installed in the upper main gully, has an effective height of 6.5 ft. It filled with sediment during the first snowmelt season after construction (A). Note that some of the deposits were removed by recession flows. A repeat photo 10 yr later shows vegetation invasion on gully bottom, at check dam, and toe of gully side slopes, as well as a pronounced decrease in slope gradient of gully walls in foreground and background.

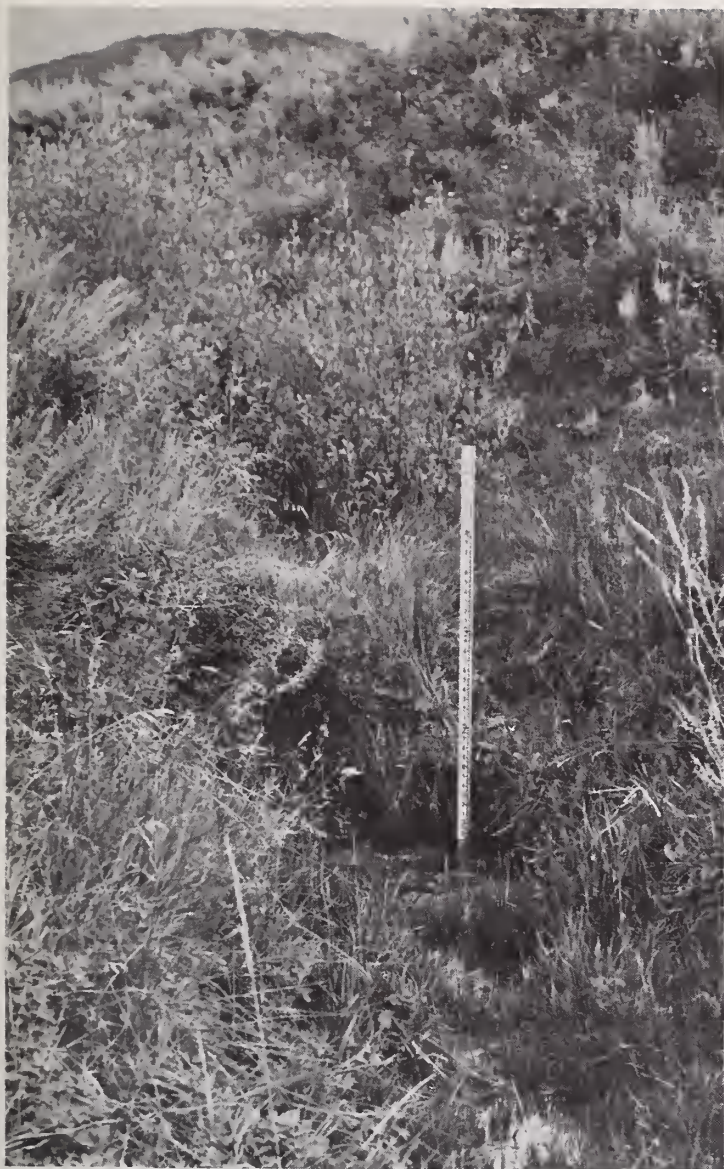
In some cases, channel scarps developed upstream from the sediment deposition wedge. (Dam spacings calculated by use of equation [2] are closer than those applied to the treatment.) The scarps were caused by pronounced breaks in gradients (nickpoints) between deposition slope and original channel slope. But not one structure was endangered 12 yr after treatment. The luxuriant growth of channel vegetation (fig. 11) almost stopped the upstream advance of the scarps.

Figure 11.—Channel scarp, 1.7 ft deep in a gully with no structural treatment, is nearly hidden by a dense mat of vegetation. The vegetation substantially reduces the upstream advance of the scarp.

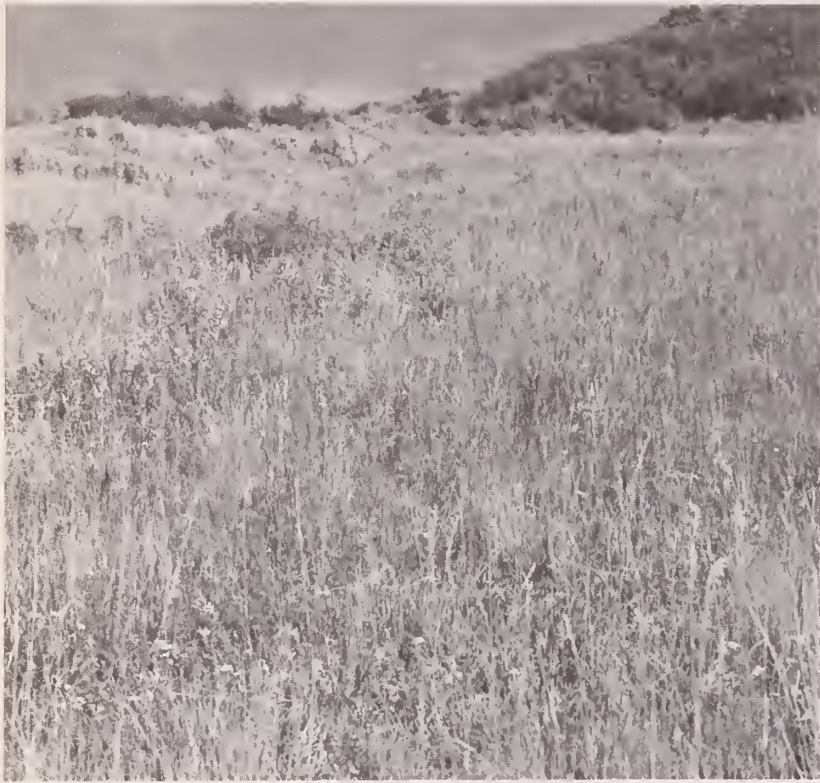
Figure 12.—Waterway 9, 12 yr after conversion of the gully once located on the left margin of the seeded area. View is upstream.

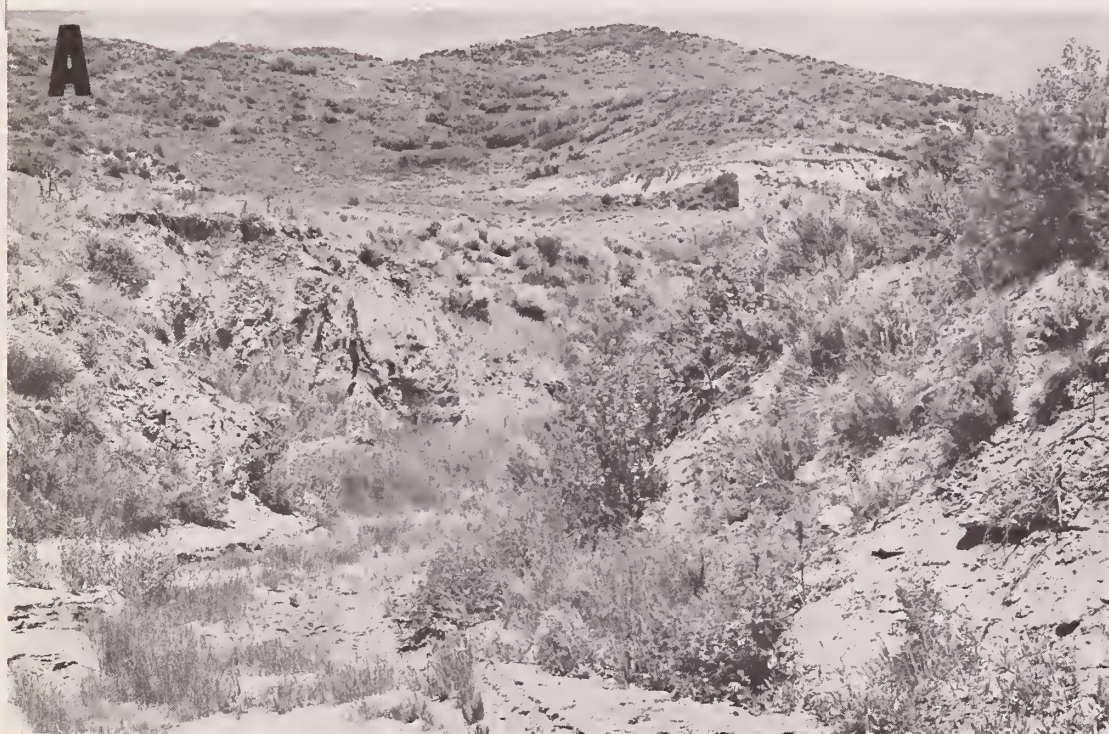
Figure 13.—The main gully after treatment in 1963 (A). Note the raw bottom and many raw gully side slopes. Thirteen years later (B), grasses and willows cover the bed, and herbaceous vegetation is invading the side slopes.
